CAMERA INSTALLATION IN HELIO COURIER AIRCRAFT (A)

Engineering Report No. 1216  
Date 12, Oct. 1976  
Page 1 of 8

TITLE: CAMERA HOLE MODIFICATION  
\_\_\_\_\_  
\_\_\_\_\_

AIRCRAFT MFG.: HELIO AIRCRAFT CO.  
MODEL: HELIO COURIER H. 250  
REG. NO.: CF-ZWL

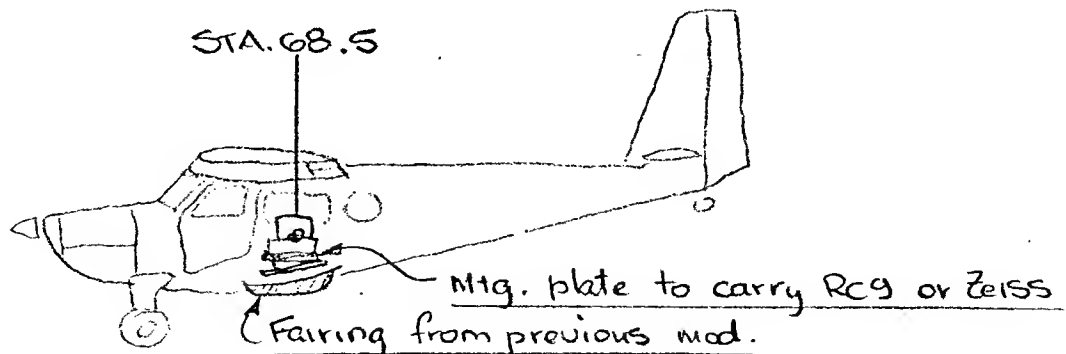
The existing tubular frame is modified as per the referenced drawing to permit installation of the RC-9 & Zeiss wide angle lens cameras. A 1/4" aluminum alloy plate used for tying down the cameras is then fastened to the modified framework with 18 #10-32 bolts & anchor-nuts.

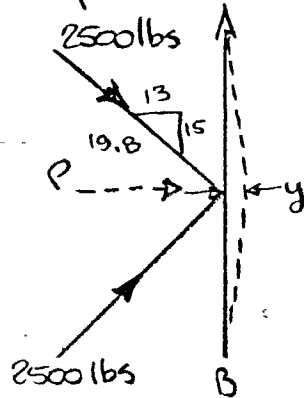
Assuming that this load and a similar load from member DE are both fed into member AB, the deflection of this cross piece can now be calculated.

Total point load on AB :

$$\begin{aligned}
 P &= \left( \frac{13}{19.8} \times 2500 \right) \times 2 \\
 &= 1641 \times 2 \\
 &= \underline{\underline{3282 \text{ lbs.}}}
 \end{aligned}$$
